# Manhole Inspection Summary

Manhole # S43C2\_022MH

**Location** Address: **3795 W Bay Ave** Cross Street: **Washburn Ave.**

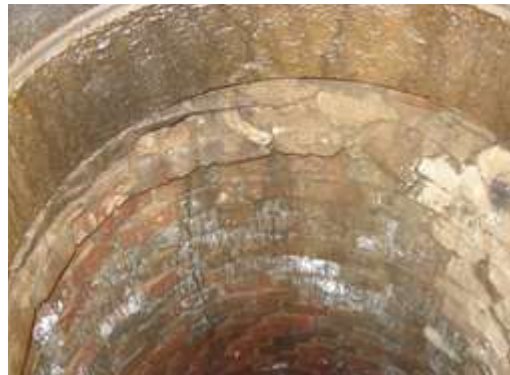
Defect 1

**Chimney / Frame Adjustment** ☒ Exists Material: **Brick** ☐ Parged Height: **60** (in.)  
Condition: ☐ Sound ☐ Cracked ☐ Root Intrusion ☒ **Loose Brick** ☐ Deteriorated  
Infiltration: ☐ None ☐ Joint ☒ **Cracks** ☒ **Mortar** ☐ Roots ☐ Wall

Mortar/loose bricks

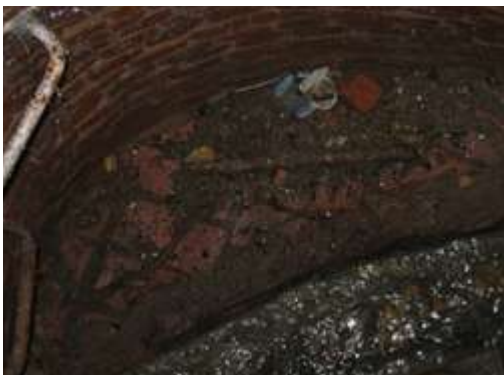
Defect 2

Debris

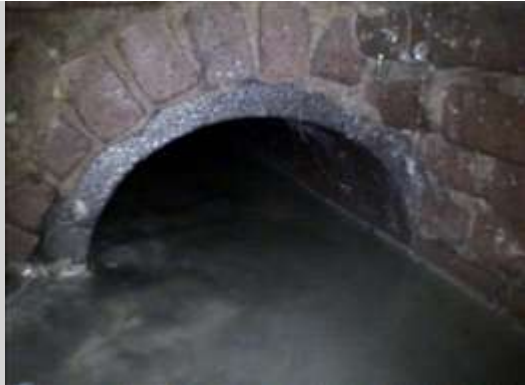
12 O'Clock Outflow

15 in. Circular Gravity Sewer  
Pipe Out @ 12 O'Clock

Pipe Height: **12** (in.) Rod and Bar (Angled)  
Pipe Material: **Clay** ☐ Pipe Lined  
Invert Depth: **10.29** (ft.) Flow Characteristics: **Fast**  
Deposits: ☒ None ☐ Mud ☐ Sludge ☐ Debris ☐ Grease  
Silt Depth: (in.) Deposits Extent:  
Infiltration: **None** Pipe Seal Cond: **Sound**

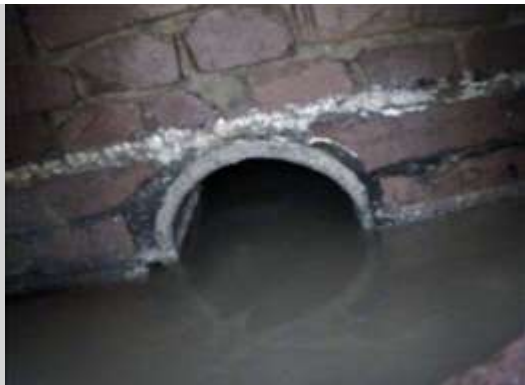
3 O'Clock Inflow

6 in. Circular Gravity Sewer  
Pipe In @ 3 O'Clock

Pipe Height: **3.6** (in.) Rod and Bar (Angled)  
Pipe Material: **Clay** ☐ Pipe Lined  
Invert Depth: (ft.) Flow Characteristics: **Slow**  
Deposits: ☒ None ☐ Mud ☐ Sludge ☐ Debris ☐ Grease  
Silt Depth: (in.) Deposits Extent:  
Infiltration: **None** Pipe Seal Cond: **Sound**

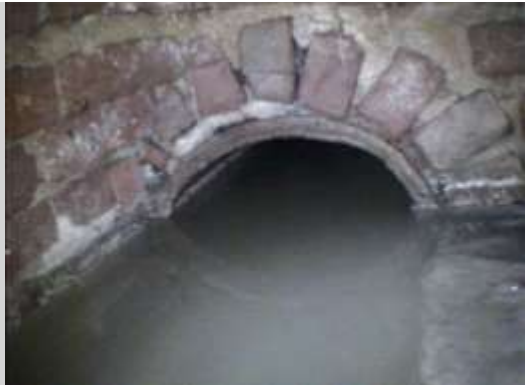
6 O'Clock Inflow

12 in. Circular Gravity Sewer

Pipe In @ 6 O'Clock

Pipe Height: **9.6** (in.) Rod and Bar (Angled)

Infiltration: **None** Pipe Seal Cond: **Sound**

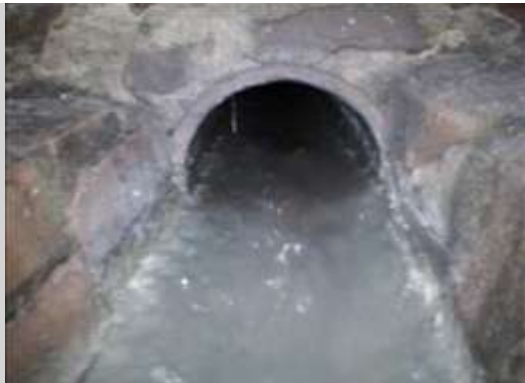
8 O'Clock Inflow

8 in. Circular Gravity Sewer

Pipe In @ 8 O'Clock

Pipe Height: **9.6** (in.) Rod and Bar (Angled)

Infiltration: **None** Pipe Seal Cond: **Sound**
